Final Report

Cobble Systems Pervious/Permeable Pavements

Stormwater Management Academy

University of Central Florida

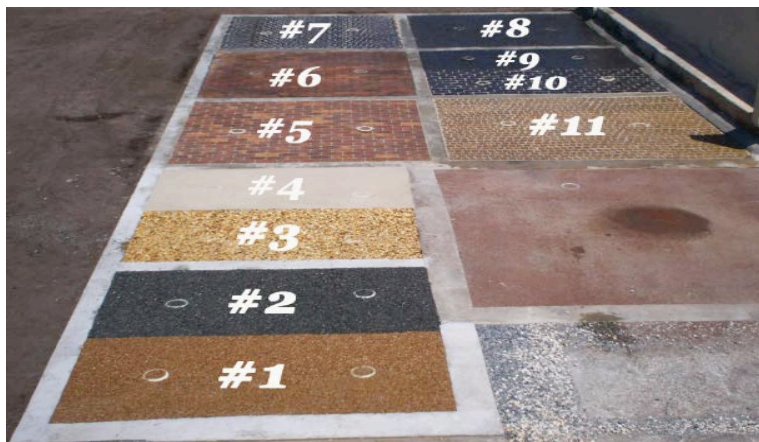
Figure 1: Project test areas

The purpose of this study was to evaluate the performance of a pervious grout developed for use with permeable pavers by Cobble Systems. The evaluation of the field performance is for permeable pavement systems with modifications made to the filler stones. A binding agent is added to eliminate loss during the rejuvenation process. The testing on several pervious and permeable pavements was performed at the Stormwater Management Academy Research and Testing laboratory (SMART Lab), UCF, Orlando in Orange County, Florida. Presented in Figure 1 is a picture of the test area with eleven different pavement systems. Cobble Systems supplied the required materials and installed the pervious/permeable pavements at the research site. The company is located in Orlando, Florida and operates consultancy services for the design and installation of pervious/permeable pavements.

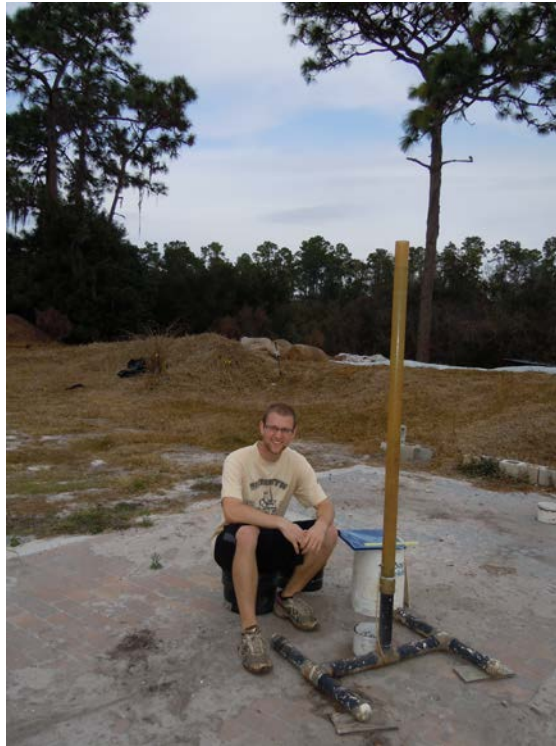
Figure 7: ERIK Testing in Progress

To run an infiltration test the following steps and conditions must be achieved. First, equilibrium needs to be achieved prior to recording data for both the short ring and long ring tests. For the short ring ERIK, a constant head is maintained with a hose prior to adding water from the measurement reservoir (see Figure 5, Figure 6, and Figure 7 for illustration of measurement reservoir). Once a constant head is maintained, the rate of water addition is matched with the measurement reservoir and the timer is started when the water level passes the top mark. The time taken for the water level to move past each successive mark is recorded. Each mark in the 2 inch diameter measurement reservoir corresponds to a 0.5 inch drop in the 6 inch diameter embedded ring. This procedure is repeated 5 times to ensure a robust data set. With this data, the infiltration rate can easily be calculated.

For the long ring ERIK this means fully saturating the material contained in the pipe as well as maintaining a constant head. When water is initially added to the embedded ring, a head of water quickly forms but air will bubble out lowering the head level. The bubbles will cease once equilibrium is obtained. Water is added to maintain a constant head from a hose. At this point water is to be added from the measuring reservoir at a rate equal to the equilibrium saturation rate maintaining the constant head of 1 inch. Once the water level in the measurement reservoir passes the top mark, the stopwatch is started. The time it takes for the water level to move past each successive mark is recorded. Each mark in the 2 inch diameter measurement reservoir corresponds to a 0.5 inch drop in the 6 inch diameter embedded ring. This procedure is repeated 5 times to ensure a robust data set. With this data the infiltration rate is then calculated.

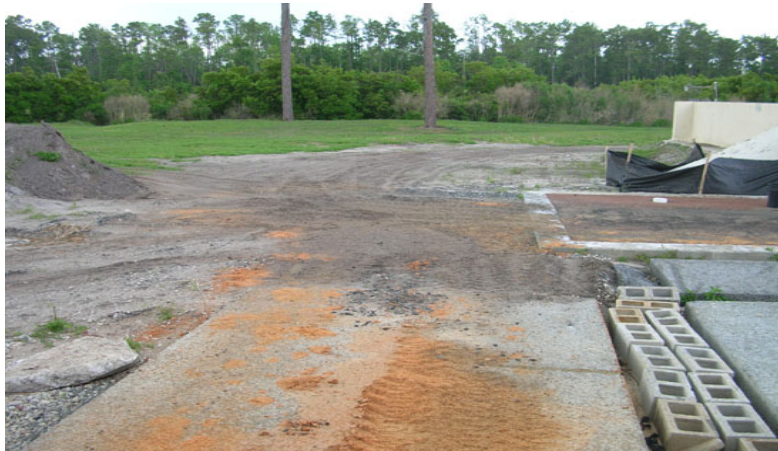
Figure 8: Test area prior to installing pavements

A total of 11 different pavement systems were installed by Cobble Systems at the University of Central Florida Stormwater Management Academy laboratory. The site prior to

installation and after completing installation is shown in Figure 8 and Figure 9, respectively. A cross section of the pavement systems is shown above in Figure 2. Pavements 1-4 are types of pervious pavements that use the Cobble Systems binder with different stone aggregate and pavements 5-11 are permeable pavements with different pervious grout. There are eight different test pads separated by footers and stem walls with each test pad being around 9ft by 9ft. Three of these test pads are divided in half. The parent earth at the site is sandy soil, AASHTO type A-3.

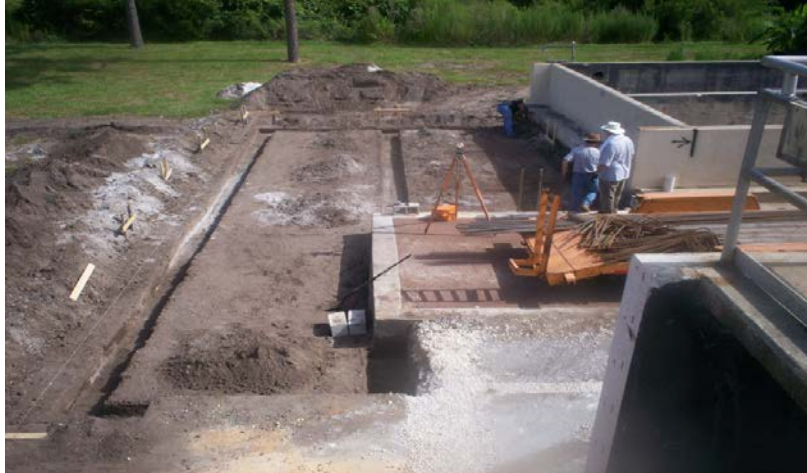
Figure 10: Test area with footings excavated

Before the pavements could be installed, the parent earth needed to be excavated and the area for the footings was cleared as shown in Figure 10. Then, Figure 11 illustrates framing for the concrete and the #5 rebar in place. Connected onto of the footings are steel reinforced stem walls shown in Figure 11, which are used to section off the different pavements.

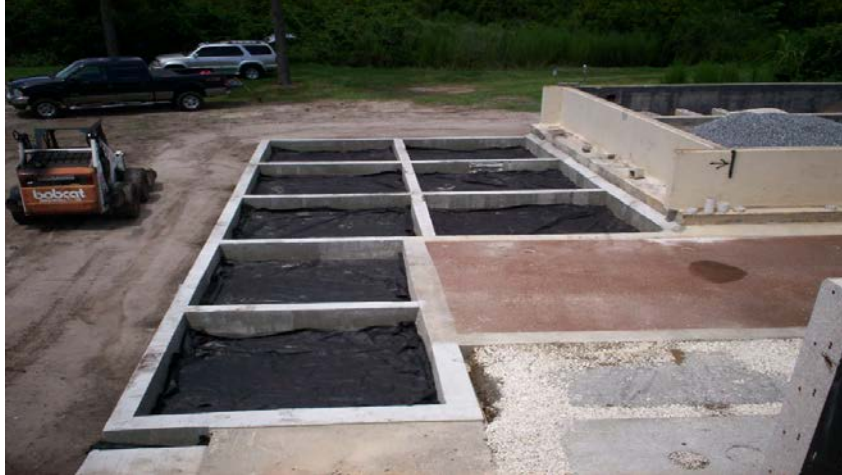
Figure 12: Filter fabric installed

After the footings and stem walls were formed, the parent earth was compacted. Filter fabric was then installed to separate the stone reservoir from the parent earth thus significantly limiting any interstitial mixing (Figure 12). A sub-base of #57 granite stone was installed and compacted in 4-inch lifts for the total height of the granite section being 10 inches (Figure 13).

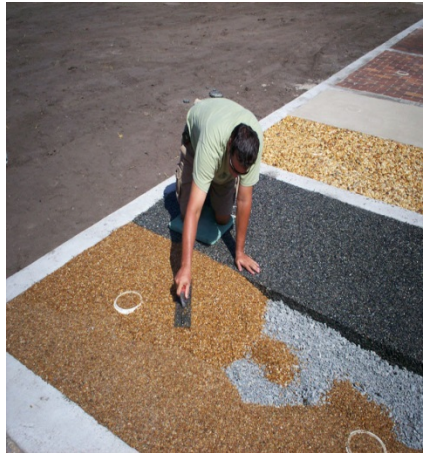
Figure 14: River Rock being installed

Two different size infiltration test pipes were installed for each pavement type, namely a short ring and a long ring. The short ring was installed in pavement surface terminating in the top two inches of the #57 granite layer and the long ring was installed through the entire system embedded 4 inches into the parent soil (See Figure 3). Next, 4 inches of #89 granite stone was installed and compacted on top of the #57 granite stone. The different pervious and permeable pavement surface layers were then constructed on top of the #89 granite stone. Figure 14 shows the pervious river rock surface layer being laid on top of the #89 granite stone and Figure 15 illustrates the porous grout being installed in one of the paver test pads. The completed

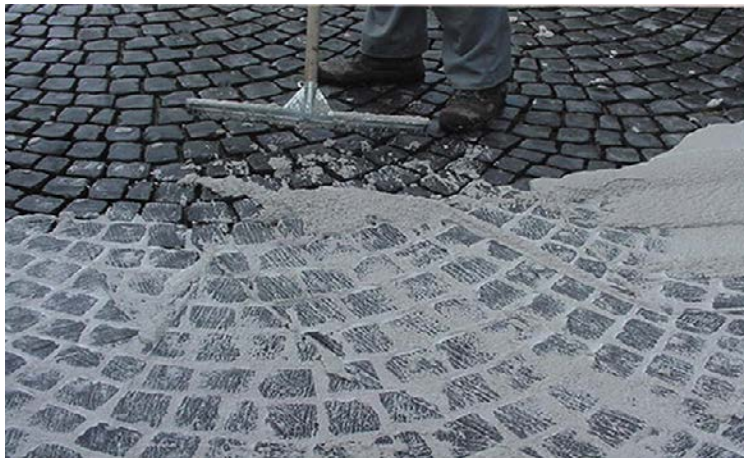
Figure 15: Ecosystems Grout being installed

Permeable pavement systems typically consist of impervious brick pavers and filler stone (usually #89 granite chips but #89 limerock is also used). This filler stone is used to add strength and increase contact between bricks. The voids of the filler stone are typically 15-35% of the total volume of the coarse aggregate (Mary Vancura 2012). The use of filler stone is necessary but can be problematic when maintenance is performed on these systems and the filler stone is removed with the sediment (University of Maryland 2011). This represents an added cost to the owner and a drawback to these types of systems. The recommendation for the total frequency of the vacuum sweep is two times per year (Lake County Forest Preserves 2003). To address this issue a permeable grout was developed by Cobble Systems which uses a poorly graded sand or #89 stone with EcoSystems Grout™ (a two part epoxy binder) to make a permanent, pervious filler.

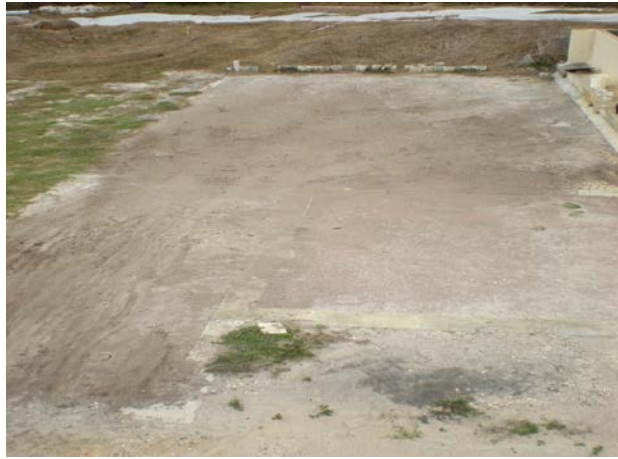
Figure 16: Pavements post loading of sandy soil

with silicon to eliminate water from leaking. This test collar allows for a head of water to develop above the system, for this testing a 2 inch head was used. The test collar needs to be taken off and reinstalled before and after each infiltration test done so vehicles can travel over the pavements unobstructed. After about nine months, the pavements were loaded with a roughly 2 inch thick layer of sandy soil (A-3 soil) as shown in Figure 16. The sandy soil was loaded and compacted with a bobcat in addition to washing the soil into the pavement with a hose. This helped the soil particles enter the pavement system and increased the compaction capacity. Another round of infiltration testing was done to observe the effect of soil loading on the pavements.

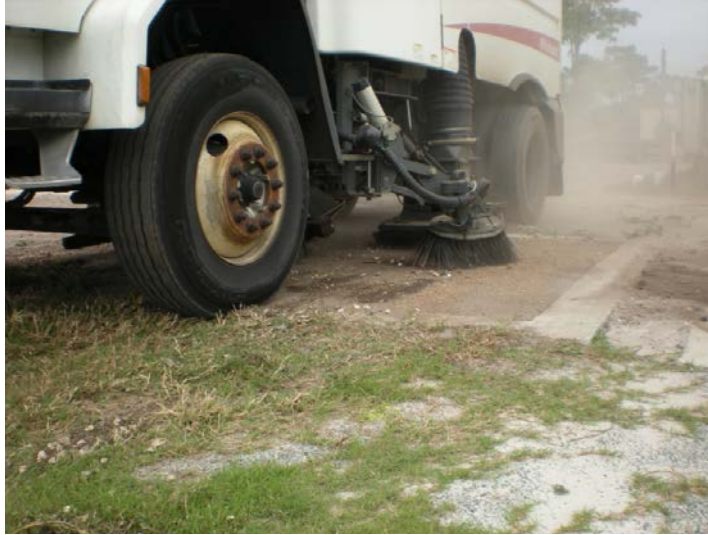
Figure 17: Sweeper truck cleaning the pavements

A standard sweeper vacuum truck (Figure 17) was selected to rejuvenate the pavements and a method was adopted from previous research done at the Stormwater Management Academy. To increase the amount of particles being removed, water was added to saturate the pavements to allow the fine grained sediments to reach their liquid limit, become plastic and mobile, and then be removed by the sweeper truck shown in Figure 18 and Figure 19 (Manoj Chopra 2011). More infiltration tests (ERIK tests) were performed to observe the effects of rejuvenation on the pavement systems.

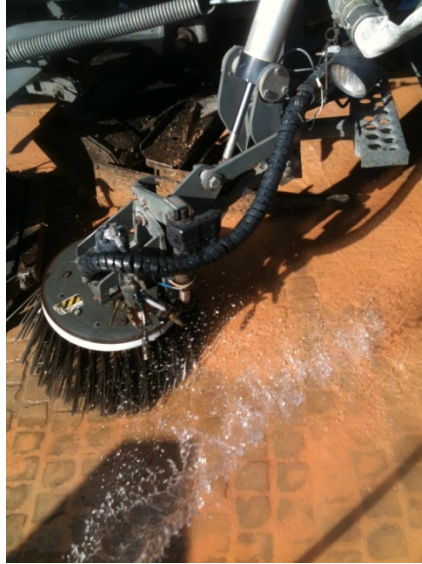
Figure 19: Saturating the pavements while the sweeper truck

The next sediment loading regimen was with a silty-sandy soil (A-2-4). The sediment loading was performed using procedure as previously discussed with the sandy soil. More ERIK tests were completed to observe the reduction in infiltration due to the loading of the silty-sandy soil. Following those tests, the pavements were rejuvenated in the same way as previously shown, which is with a vacuum sweeper truck as shown in Figure 19 and Figure 20. ERIK tests were then performed to achieve data on how well the pavements were rejuvenated.

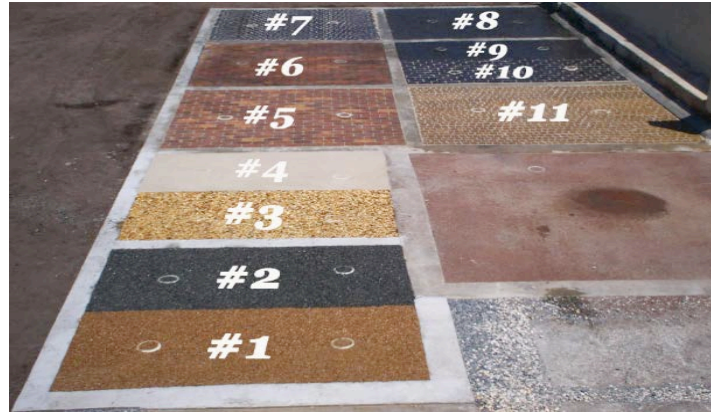
Figure 21: Pavements after completely installed

Presented below in Figure 21 is a numbered layout of the pavements after they were installed. For the short-ring tests, the rings were installed flush with the pavement surface and imbedded 4 inches into the top layer of #89 granite stone.
